How to use Physics of Failure Analysis for Roller Bearing Failures

How to use Physics of Failure Analysis for Roller Bearing Failures: A tutorial explaining the Physics of Failure method applied to regularly failing roller bearings in a dewatering press. After three years of exhaustive efforts to solve the cause of the bearing failures it was decided to test Physics of Failure Analysis with the aim of finding a lasting answer.

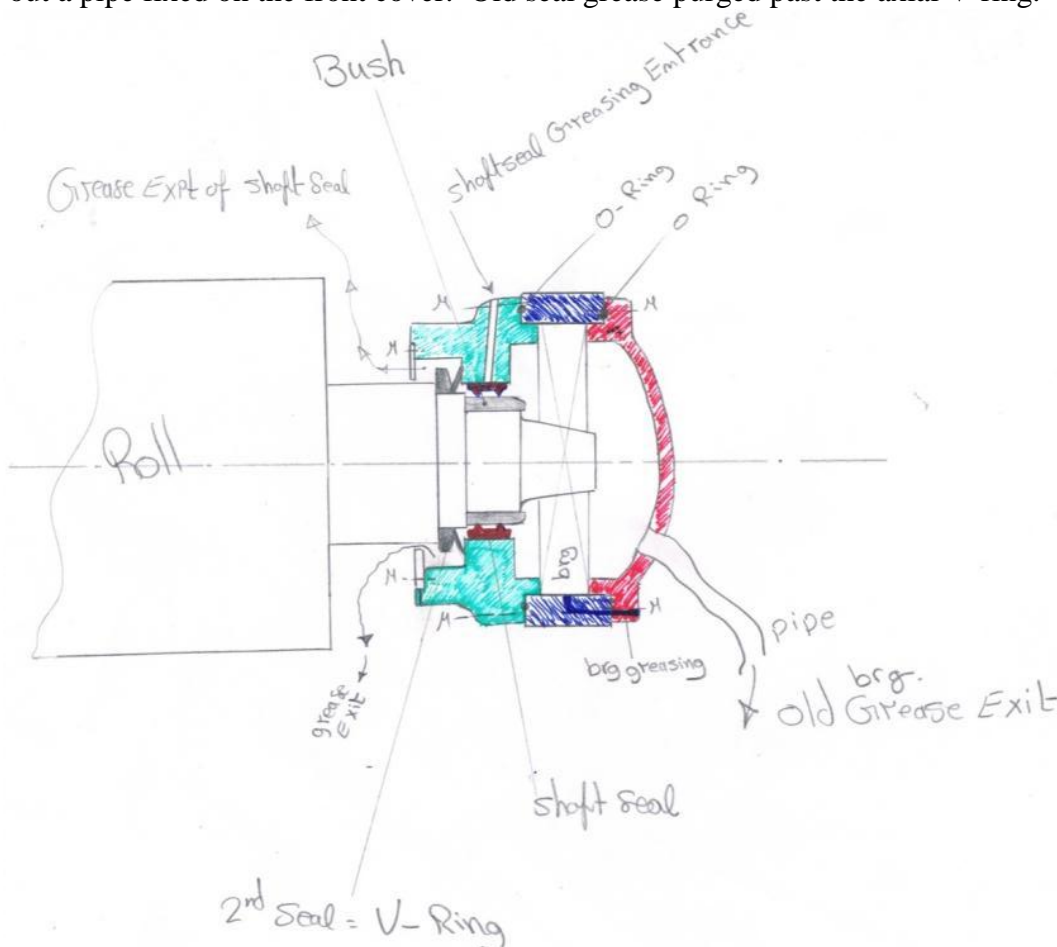
Figure 1 De-watering Press Roller Fixed End Bearing Arrangement

Figure 1 is the bearing arrangement at the roll ends. The bearing was a spherical roller tapered bore bearing 23236 CCK/W33 installed directly on the taper shaft. Old grease from the bearing purged out a pipe fixed on the front cover. Old seal grease purged past the axial V-ring.

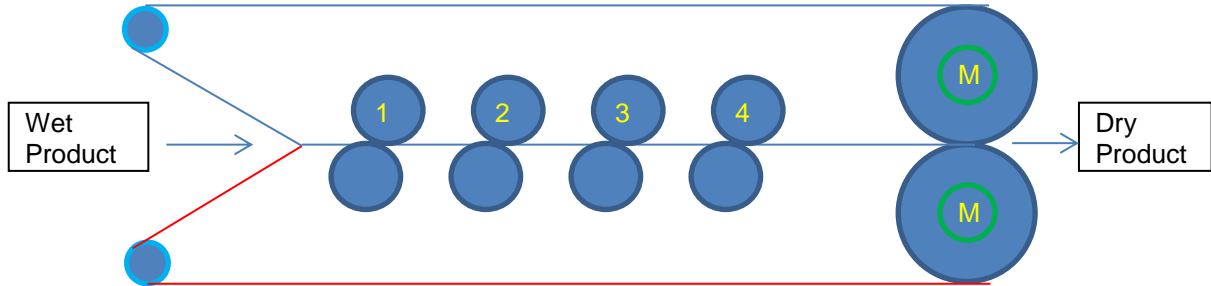
Figure 2 Roller Arrangement

Figure 2 shows how the roll sets were driven by the wire, with no direct motor drive. Operating temperature ranged 50-70C. The pressing rolls were in a chamber with a vapour extraction system at the top.

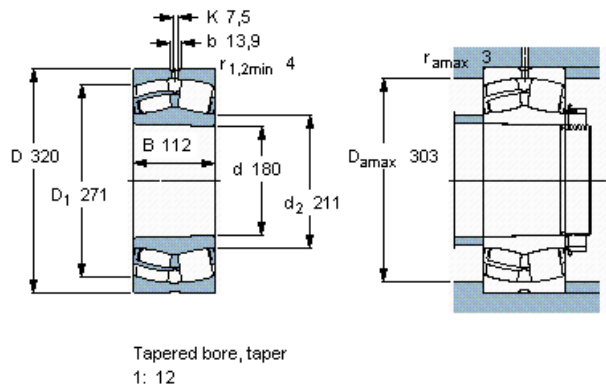
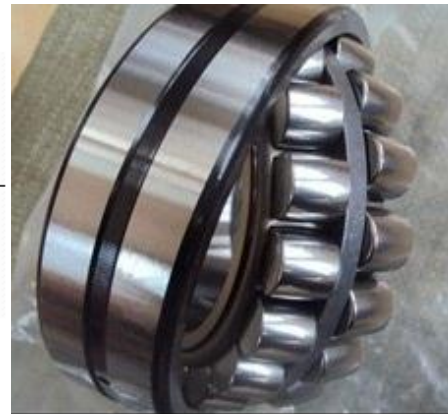
Figure 4 23236 CCK/W33 Bearing Details

The spherical roller bearing design details were as shown in Figure 4.

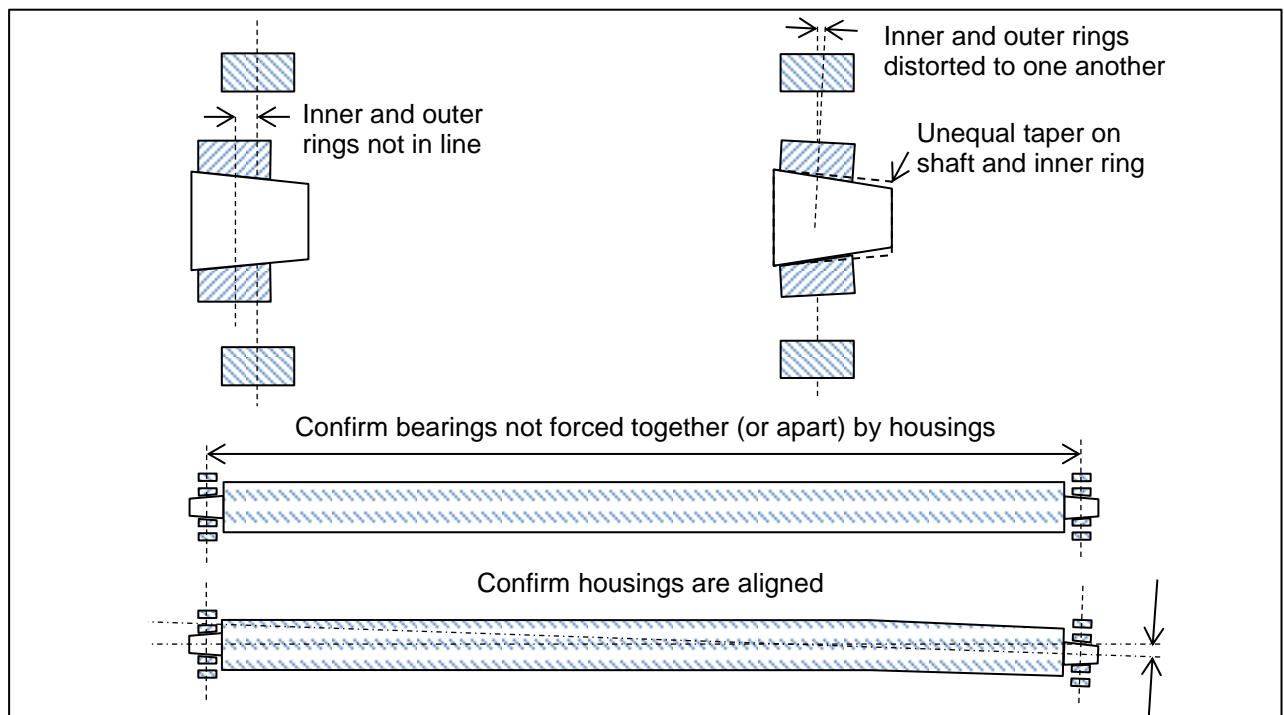
Figure 6 Possible Causes of Bearing Failures

We have reduced the bearing failure scenario down to two potential situations—high stress and hydrogen generating chemical reaction. Each of these is to be closely investigated before looking at other possible failure mechanisms. The question now becomes: What can occur to a roller bearing to create the two situations identified? Table 3 lists possible situational causes and how they can be tested. Figure 6 shows the type of problems that need to be checked.
